Appendix A: Drilling and Blasting Management Plan

Project ref:	BAA.4008		
Project name:	Rothera Modernisation Project		
Activity plan ref:	BAA4008-BAM-ZZ-YYY-SP-WA-0007	Revision	Draft 04
Activity plan title:	Drilling, Blasting and Processing Management Plan

This document details management of drilling, blasting and rock processing operations in order to create a rock platform for the modernization construction works. It does not include placement of fill or other construction activities.

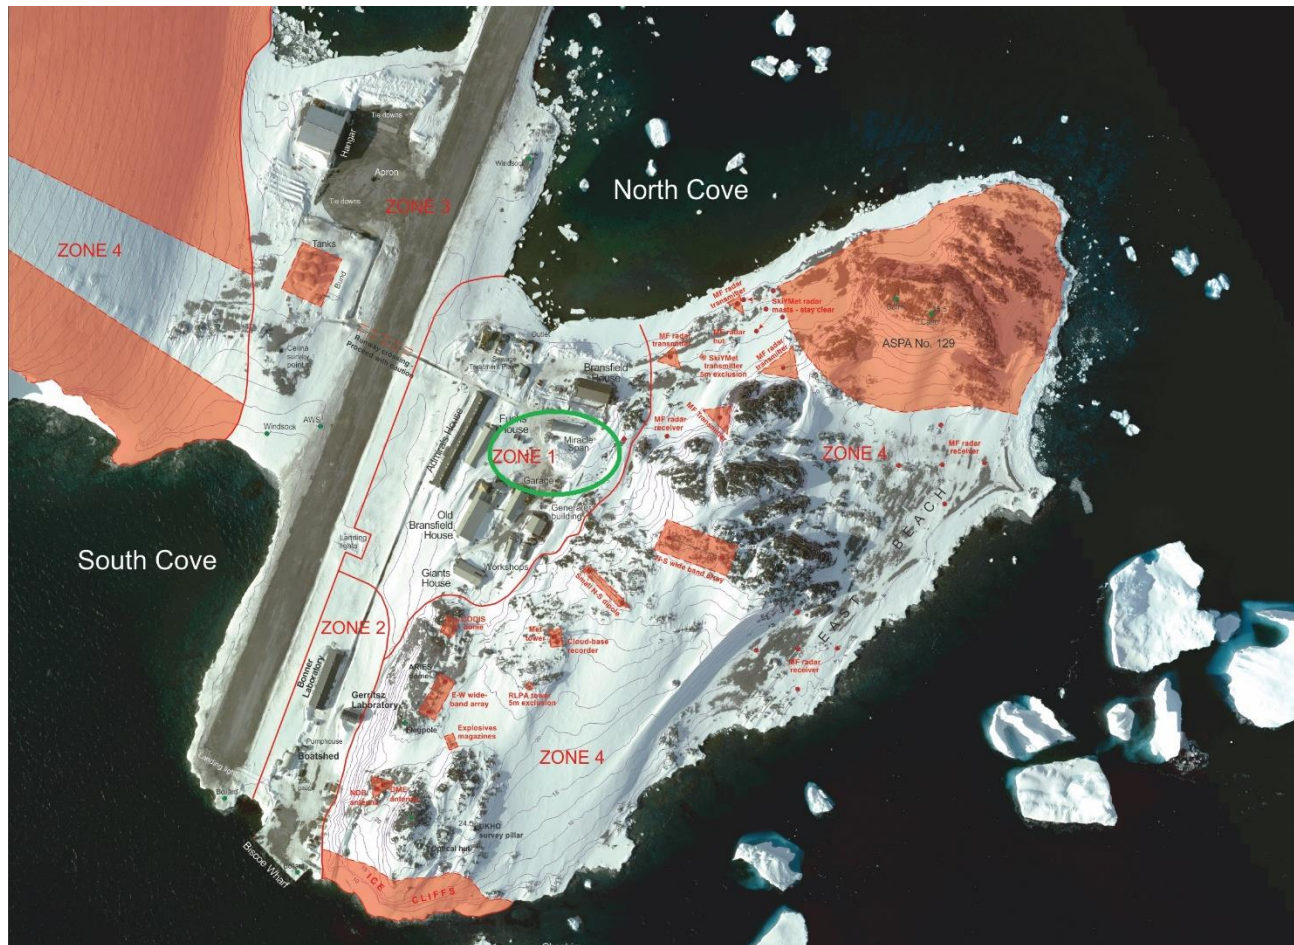
Figure 1 – Rothera Research Station showing the proposed blasting area.

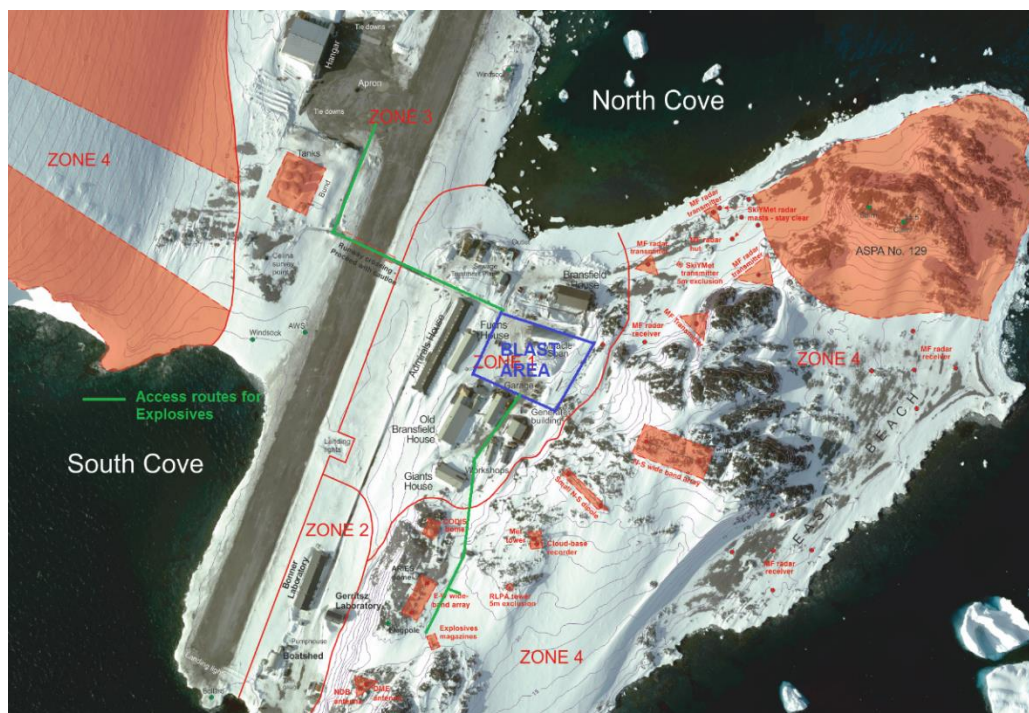
Figure 7 - Access route to the quarry shown in green.

Access to existing station facilities must be strictly controlled during blasting operations, immediately around the blasting area during drilling and charging and additionally at the time of firing.

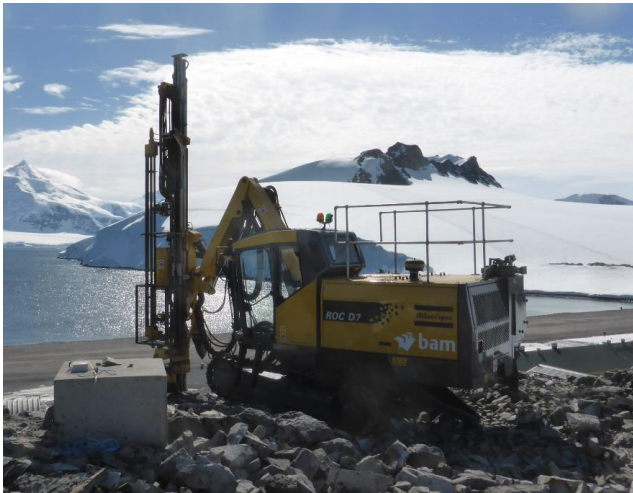
Figure 8 – Atlas Copco D7 tracked drill rig at Rothera.

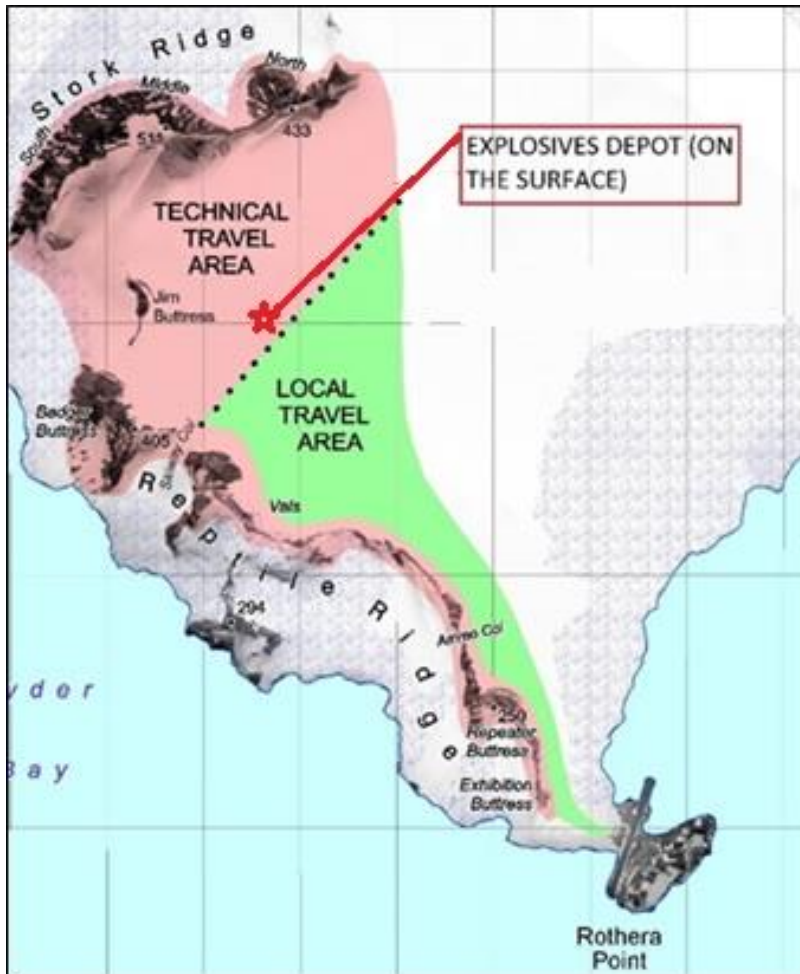
Figure 10 - Ski-way explosives storage location.

The boxes of Pentex boosters must be stored at one end of the depot to allow ease of access and stacked as high as practical. Boxes must be wrapped in heavy duty plastic to protect against snow ingress, the bottom boxes should be individually wrapped and the stacks can be wrapped together afterwards in sections.

The tarpaulin must then be folded back over the top and significantly overlapped – giving side to side cover and adequate protection from snow ingress. The end tarpaulin will need to be positioned to allow complete coverage of the depot ends. Spare shipping pallets from relief will be placed against the edges and on top of the depot as required, to spread any ratchet strap force and to provide a solid buffer if any digging is required. Ratchet straps will be spaced sensibly to provide enough stability to the structure.

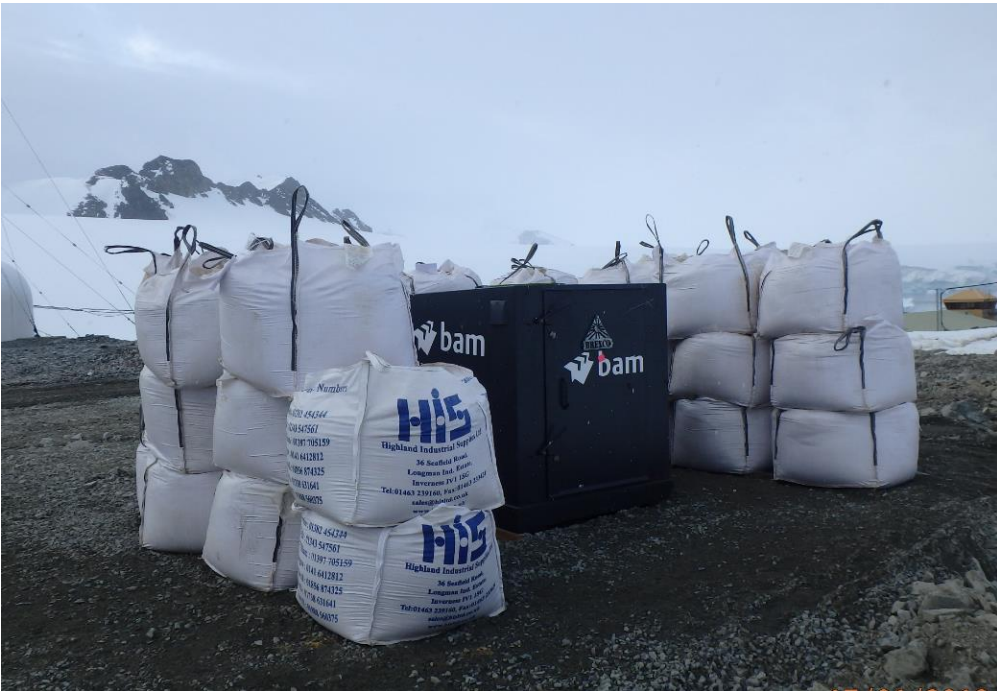
Figure 13 BAM on-station explosives magazine.

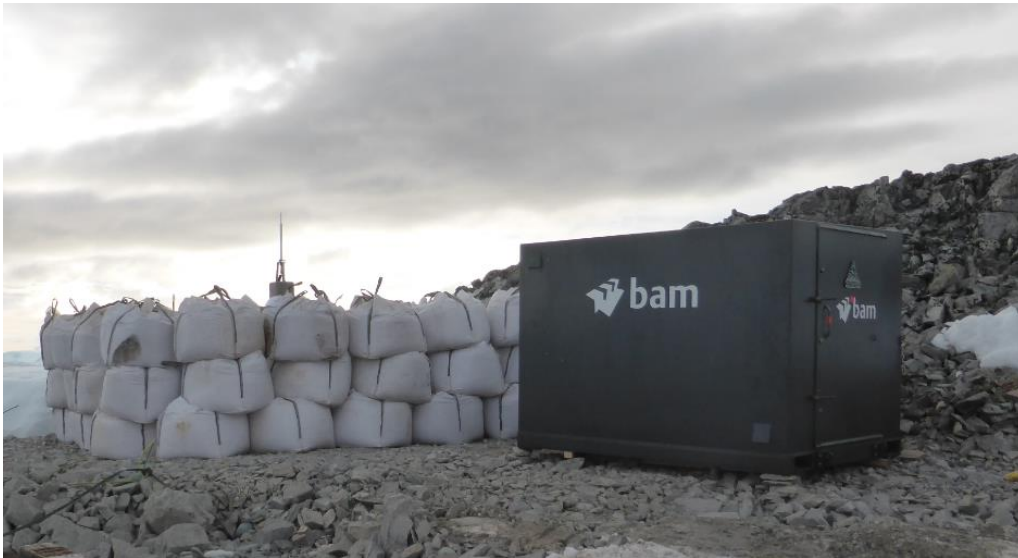
Figure 14 – BAM on-station detonator magazine. The existing BAS magazine is enclosed by the bund.

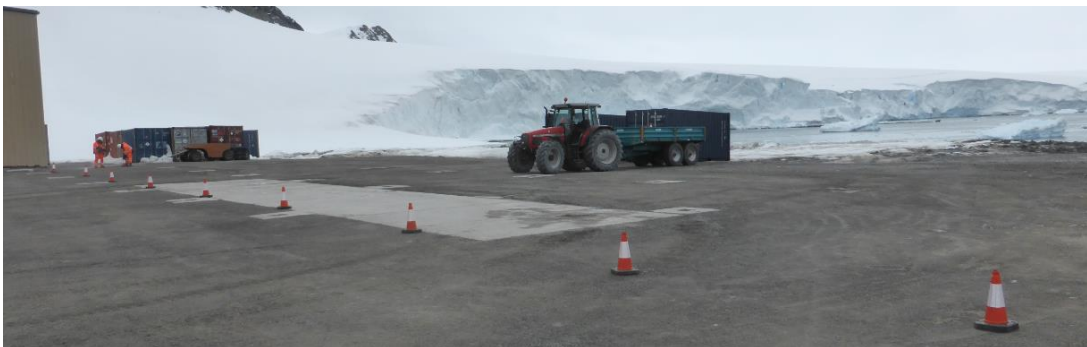
Figure 15 – Apron transfer area.

Once the containers are in the temporary storage location, the detonators should be removed first and taken the short transfer to the on-site storage location. The main explosives should be supervised by the Shotfirer, or appointed person until all loads have been transferred to the field storage location, except for a reserve stock which can be kept in the Rothera base magazines. This activity is likely to take some time. In the event that the transfer to the glacier storage is not completed in one day, the containers should be locked and the cones and rope cordon preserved. The explosives supervisor and station leader may then determine if the explosives can be left unguarded overnight, provided that no activities are being undertaken in that area. Every effort should be made to remove the explosives to the glacier storage at the earliest opportunity.

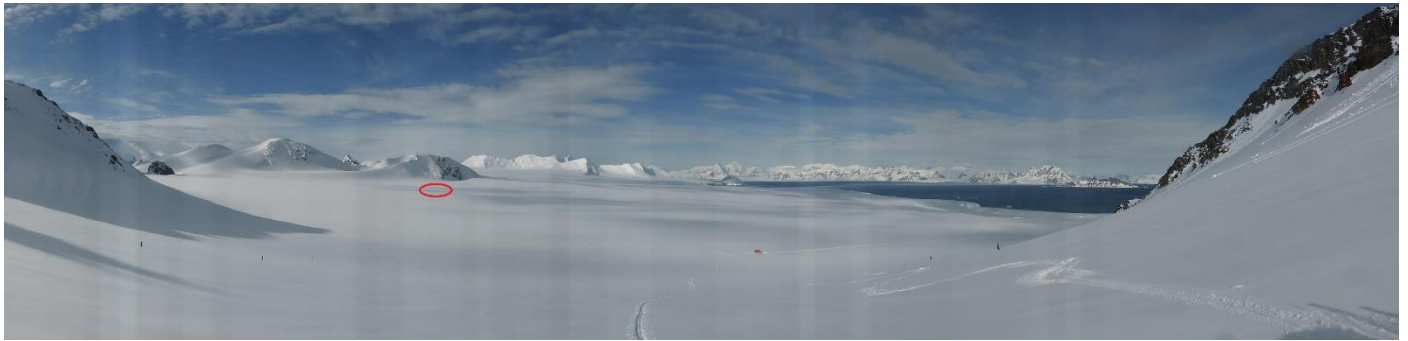
Figure 16 – Explosives storage location on the glacier.

Due to the large explosives requirement for the blasting operations it will not be possible to store the project explosives at the current BAS station storage location and instead these explosives will be stored on the glacier as shown in figure 10 and as per the arrangements for the Rothera Wharf project.

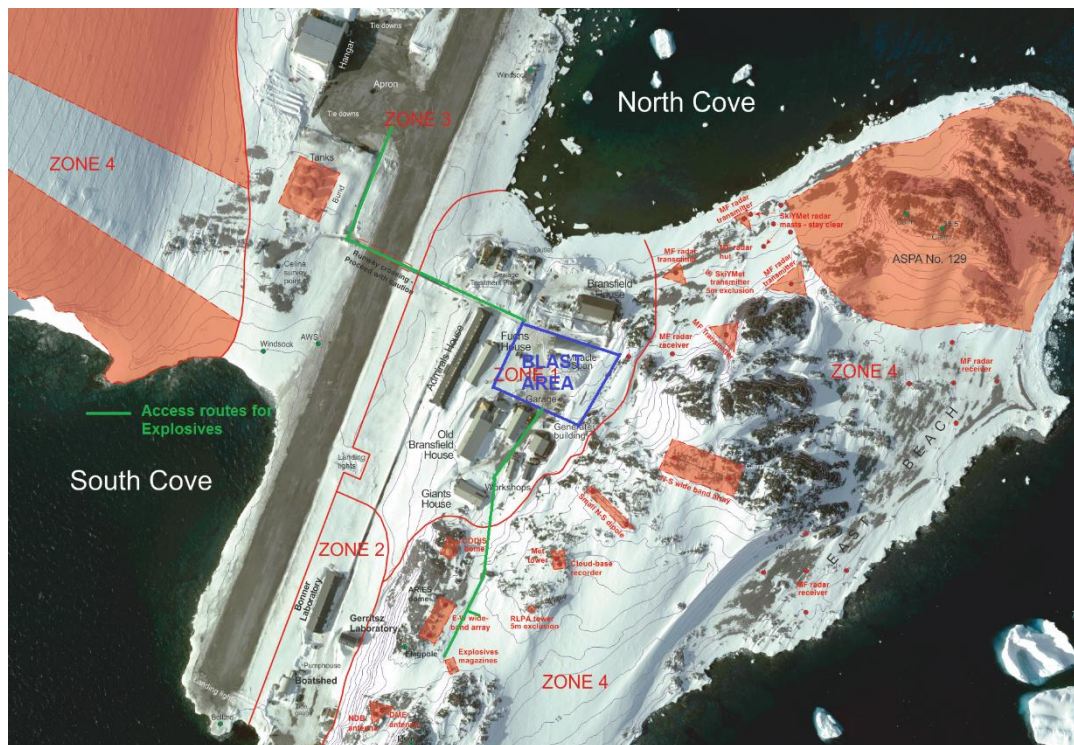
Figure 17 – Explosive transport routes and transfer areas. The transfer area may vary depending on flight operations.

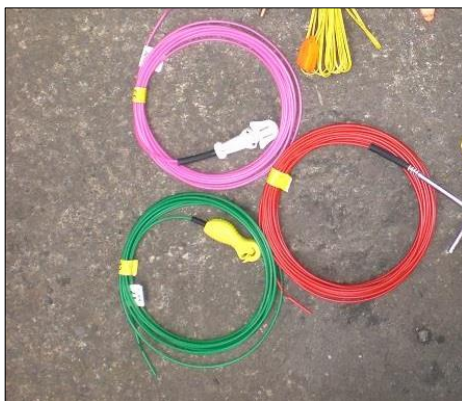
Figure 19 - Examples of non-electric detonators

Non-electric have been selected to initiate the explosives and to control the initiation sequence. These detonators are not affected by radio frequency hazards and are sufficiently robust for use in the process described below.

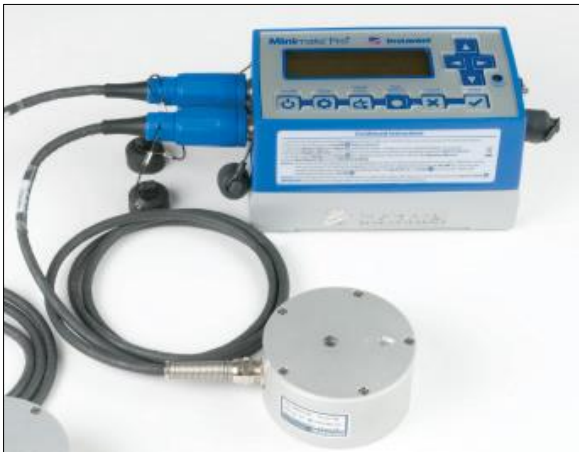
Figure 21 – Example blasting Seismograph for monitoring PPV, air-overpressure, or peak pulse pressure

Monitoring should initially be undertaken at the closest sensitive receptors of each type, or agreed on site with project and station management. Once confidence is gained that vibration limits will not be exceeded at these receptors, monitoring should continue at varied distances to obtain data for prediction models.

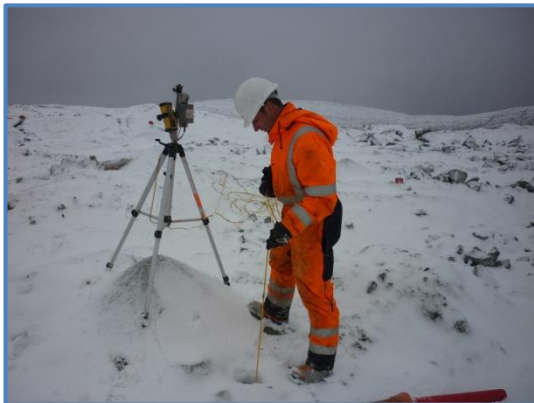
Figure 23 – Surveyor using electronic probe to survey holes

Wet or deviated holes will be surveyed by electronic probe. This information will be downloaded directly to the survey program. When using a probe ensure that the magnetic declination is taken into account.

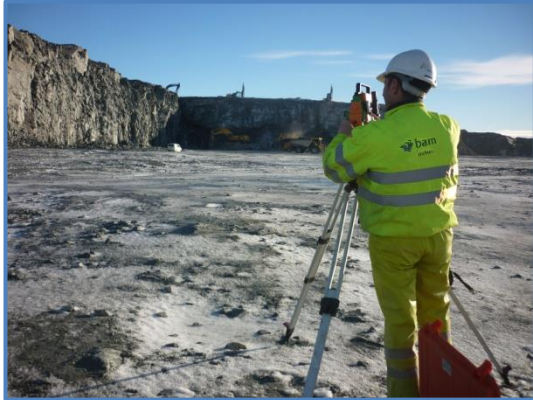
Profiling will be carried out by an experienced surveyor, using laser profiling equipment within current calibration. The profiler will submit the completed survey to the Shotfirer or the Explosives Supervisor. New or irregular faces may require to be surveyed before drilling.

The laser operator will survey the face as required by the shotfirer taking care to ensure that any open ends are included and that a sufficient density of measurements are taken to ensure the accuracy of the survey. It may be necessary to survey the face from more than one location to ensure that a suitable density of measurements are obtained and there are no areas missed.

Figure 24 – Undertaking a laser profiling survey of the face

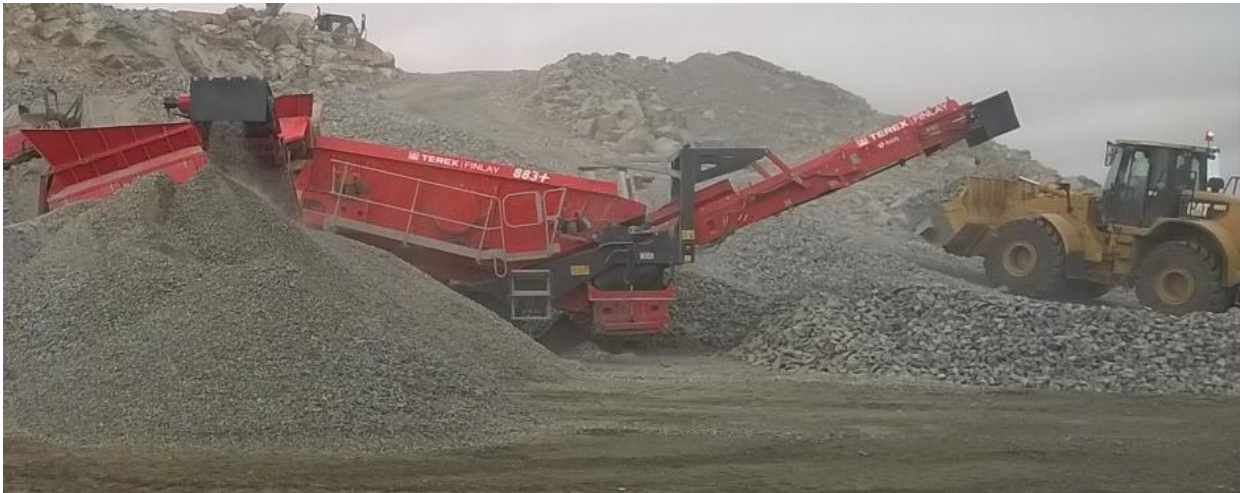
Production feed will come from as-blasted rock from the modernisation cut, augmented by additional rock from the Rothera Wharf quarry if required. All feed material will be screened to separate 0-80mm material from 80mm+ oversize using a mobile or fixed grizzly screen. This simple screening process does not impart any shape to the product. Product is then loaded to stock, or direct to the project. Oversize material will be stockpiled for use elsewhere. No crushing operations are planned.

Figure 28 - The mobile screen already at Rothera

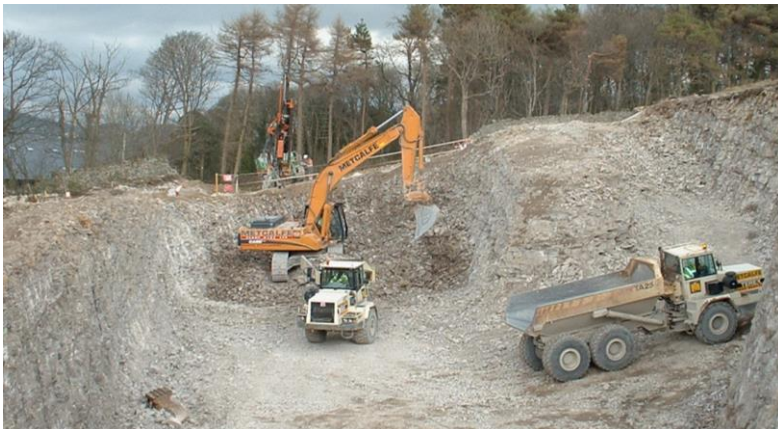
Blasted rock will be loaded using a hydraulic excavator into an articulated dump truck - as shown in the example below.

Figure 29 - Example of loading at the face

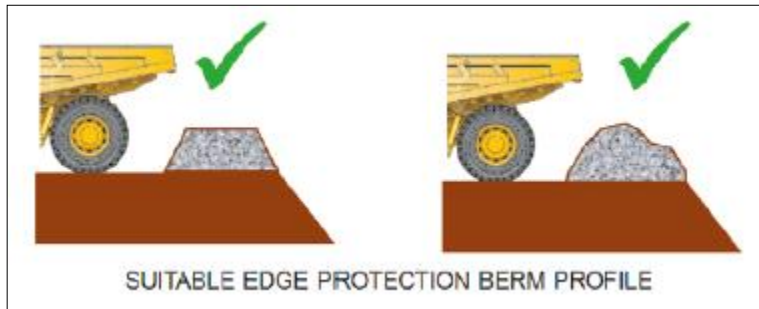
Where tipping over an edge, a protection barrier will be constructed using an excavator to prevent trucks being able to reverse too far. No ancillary plant or vehicle may enter the restricted area until allowed by the banksman or supervisor and only when tipping operations are stopped.

Figure 32 - Example edge protection for tipping operations

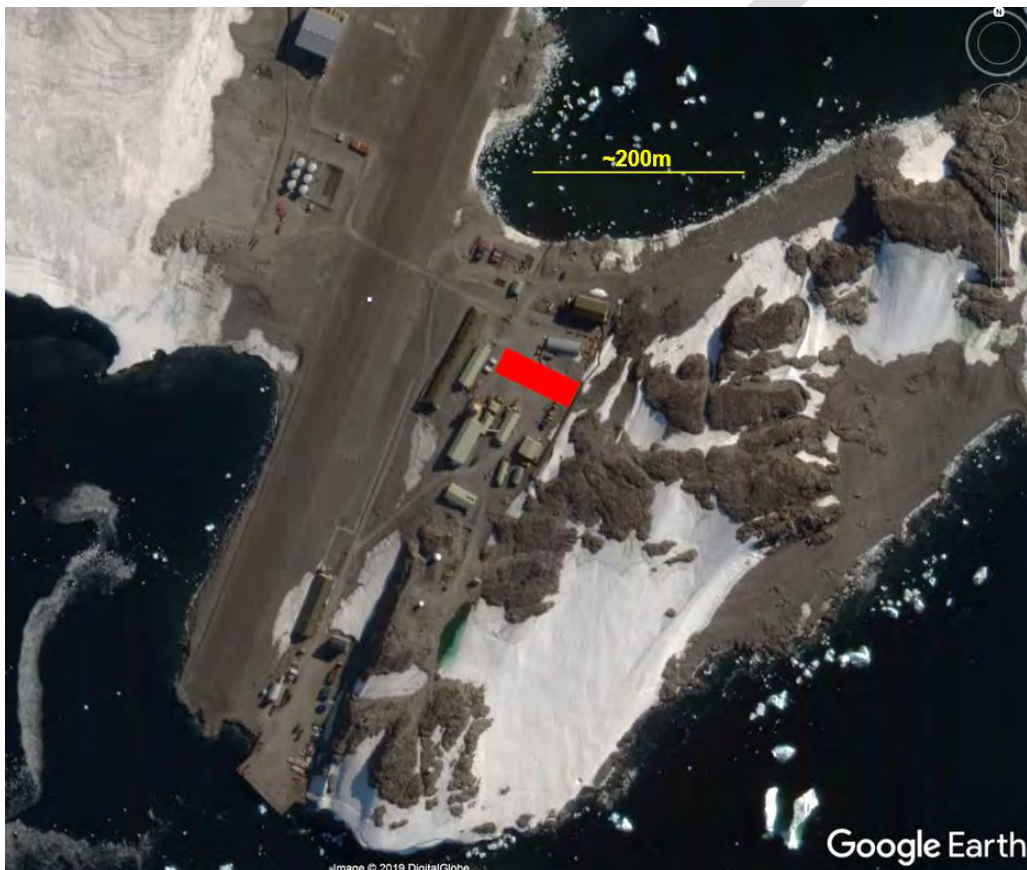
Figure 1: Indicative Site Location within Rothera Research Station

Note: Approximate position of new Science and Operations Building highlighted in red

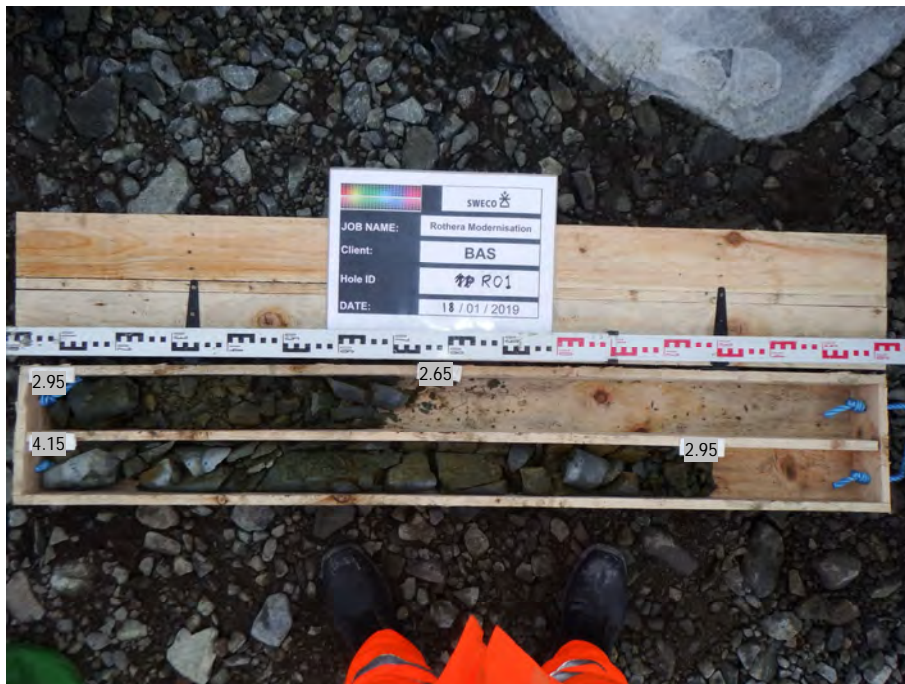
2.05 - 2.95	33	0	0	NR	13.76		2.05 (0.60)	Overburden, GRAVELS. (Driller's description).	
				NI	13.16		2.65 (1.90)	Medium strong greenish grey to grey GRANODIORITE (crystals 1 to 3mm). Partially weathered, evident from fractured zones and greenish chlorite and epidote staining. Locally highly fractured. Abundant branching incipient fractures with greenish epidote mineralisation (<1mm). Fractures at all orientations, very closely spaced (locally very closely), undulating and stepped, smooth. Fractures often have greenish (epidote/chlorite) and some dark orange (iron oxide) surface staining. (Adelaide Island Intrusive Suite). <u>3.40 - 3.85m: Subvertical fracture.</u>

Photo 1 – BHR01 2.65 to 4.15m.

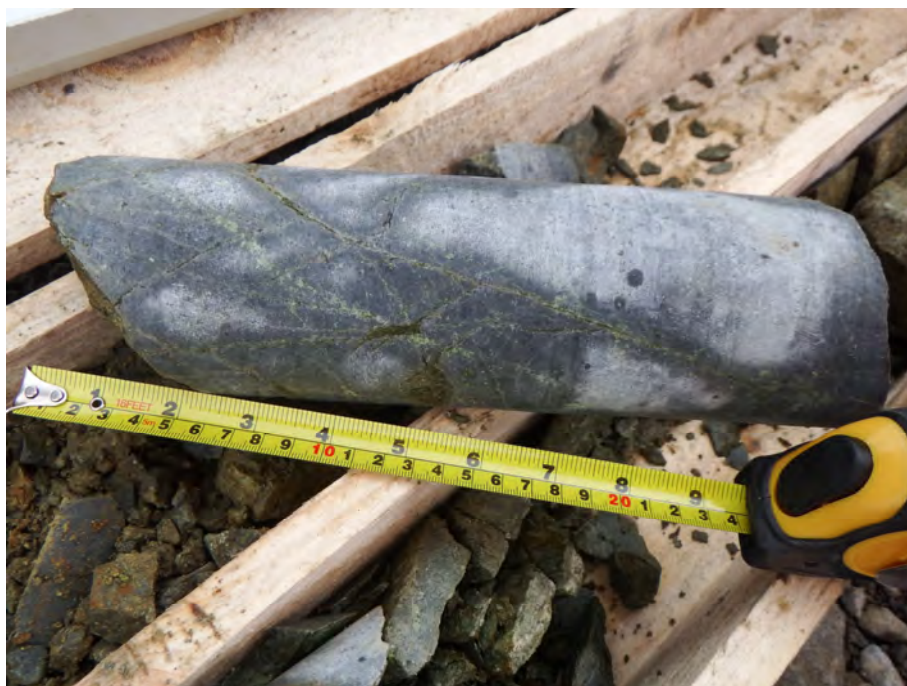
Photo 4 – BHR01 2.65 to 2.95m. Incipient fractures.

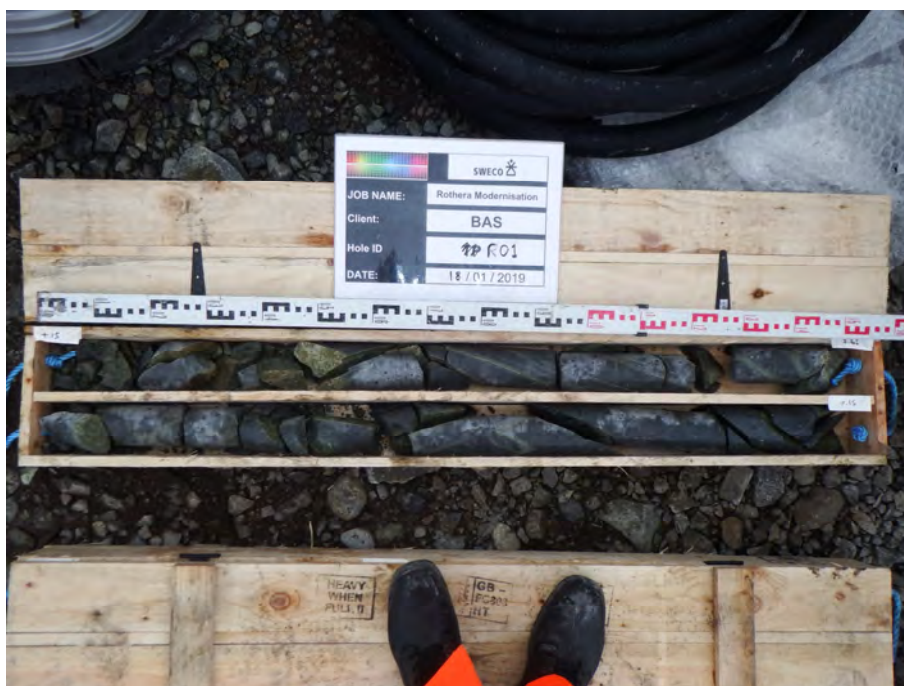
Photo 5 – BHR01 4.15 to 7.15m.

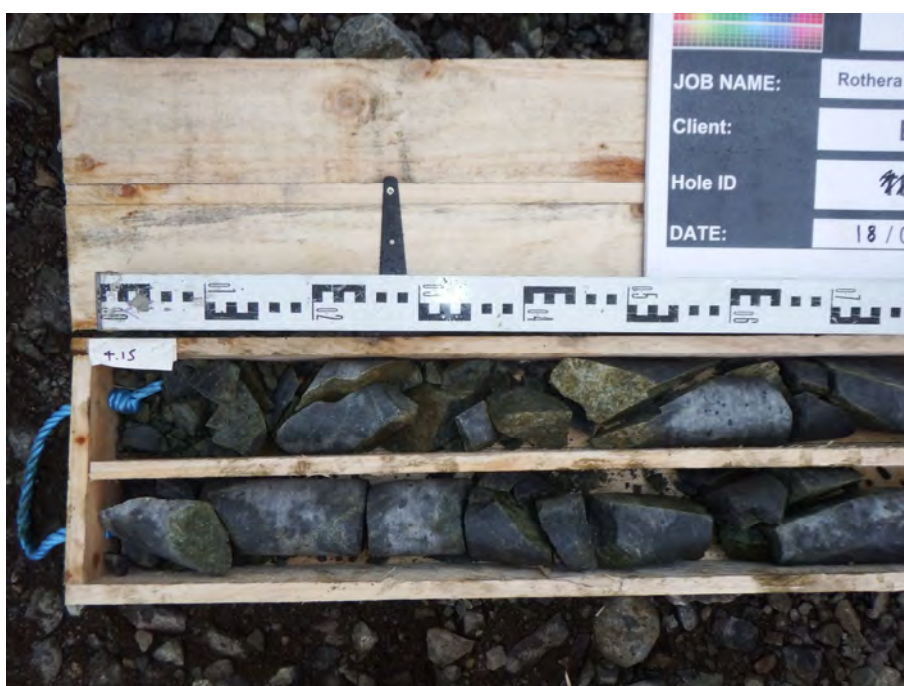
2.95 - 4.15	100	54	43	11					
				NI					
				10					
				13					
4.15 - 5.65	100	80	57	10	11.26		4.55 (2.00)	Strong to very strong grey GRANODIORITE (crystals 1 to 3mm). Frequent incipient and infilled fractures with greenish chlorite and epidote mineralisation (<2mm). Fractures mostly dipping at 60 to 90 degrees (occasionally 30 degrees), closely spaced, undulating (locally stepped) and smooth. Fractures often have light green epidote and chlorite surface staining. Occasional drilling induced fractures. (Adelaide Island Intrusive Suite).

Photo 6 – BHR01 4.15 to 7.15m.

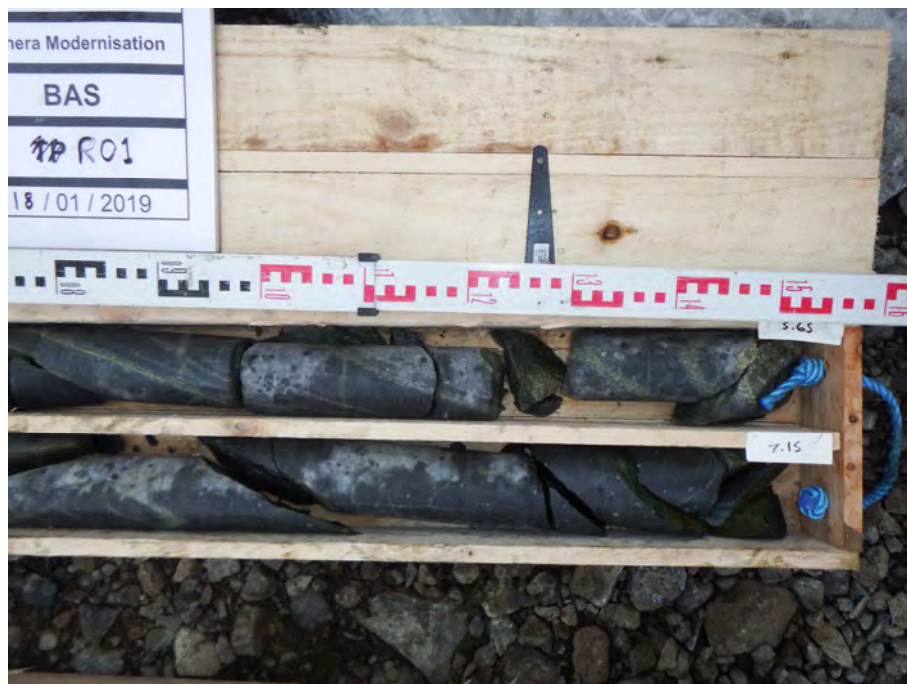
Photo 7 – BHR01 4.15 to 7.15m.

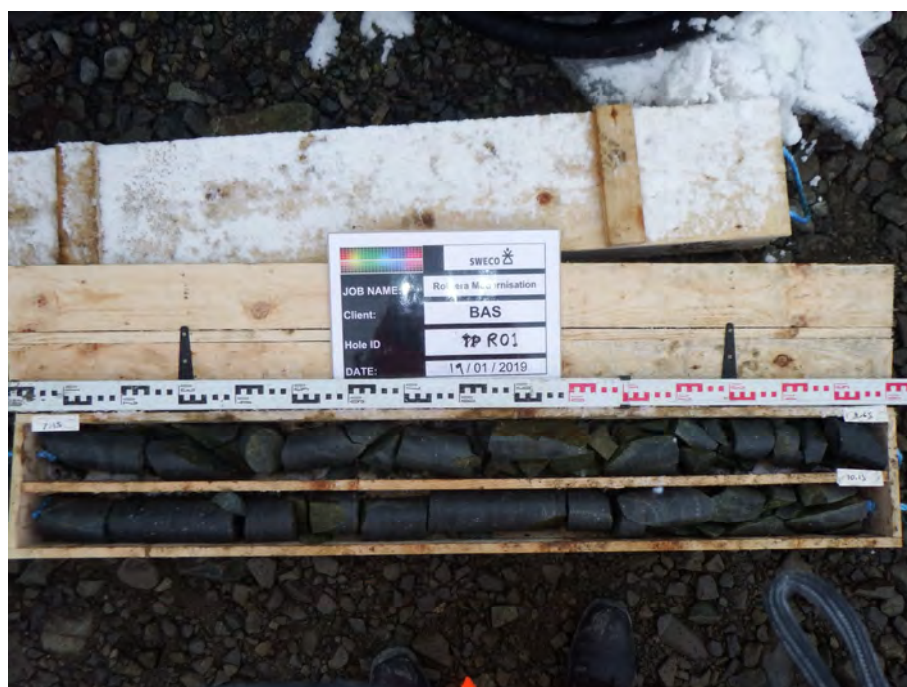
7.15 - 8.65	100	87	65	8	8.26		7.55 (7.10)	Strong to very strong grey GRANODIORITE (crystals 1 to 3mm). Frequent large white feldspar phenocrysts (<7mm). Local bands of microgranodiorite. Generally unweathered to slightly weathered. Frequent branching incipient fractures with greenish chlorite and epidote mineralisation (<1mm). Fractures mostly dipping at 60 to 90 degrees (locally 20 to 30 degrees), closely spaced (locally very closely spaced), undulating and stepped, smooth. Fractures often have	
				12					
								Continued on next sheet

Photo 8 – BHR01 7.15 to 10.15m.
